**Flood Control Project Maintenance
Levee Inspections**

Fall 2018 Levee Maintenance Deficiency Summary Report

Reclamation District No. 0150 Merrit Island

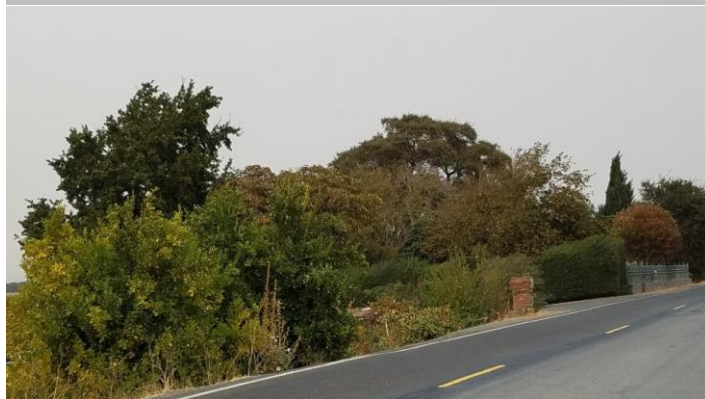
Photo 1 of 1 : FA_2018_RD0150_16_106_20181115_00135.jpg

View of landscaping that needs to be maintained and of unpermitted citrus trees on levee slope. Fall 2018

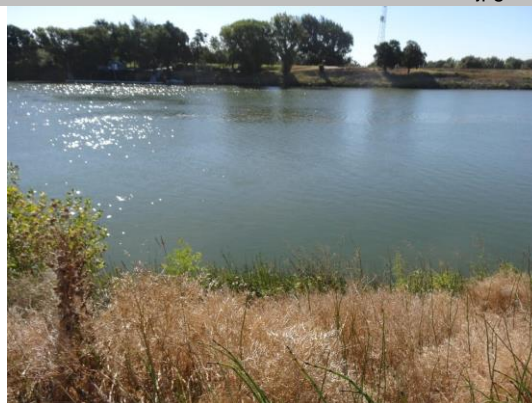
Photo 1 of 3 : UCIP_FA_2018_42700_34247.jpg

LM Start	0.23	Rating **	M	Issue No.	991
LM End	0.23	Issue Type +	En	Location *	
Category	Supplemental			GPS Latitude/Longitude	
				Start	End
Item	DWR UCIP Field Study			38.330888 °	38.330888 °
				-121.573769 °	-121.573769 °
DWR ID	22416				
Comment Code					
Inspector Comment					
FS_ID:42700 DS_ID:22416 EP_NO: N/A Repair Type: Non-Urgent Crossing Status: Found UCIP Comments: Appears abandoned and if so should be done so properly.- Dense vegetation on waterside.- Seems abandoned pipe and pump. FIELD_STRUCT_DESC: *ABANDONED* 10-inch steel irrigation discharge pipe through the levee, invert elevation 2.8 feet below the crown. Pump on the landside (LS). Concrete box on the LS. (Thomas Estate). [Additional Reference(s): DWR Levee Log, 2005. USACE Sacramento O&M Manual 112, March 1957, (RM 34.23)]. FS Date: 8/27/2013

WS view: No pipe found on waterside slope. Dense vegetation on waterside.

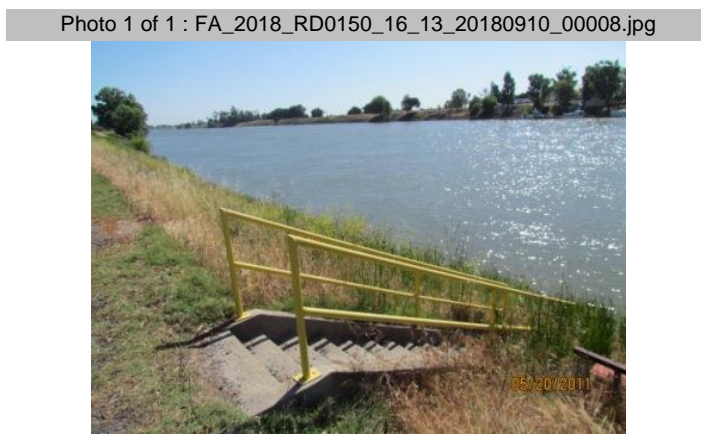
LM Start	0.38	Rating **	M	Issue No.	13
LM End	0.38	Issue Type +	En	Location *	WS
Category	Earthen Levee			GPS Latitude/Longitude	
				Start	End
Item	Encroachments			38.332647 °	38.332647 °
				-121.572140 °	-121.572140 °
DWR ID	DWR_RD0150_02_s_2012_13				
Comment Code					
ST : Stairway					
Inspector Comment

A stairway was found on the waterside of the levee. The picture was taken from the crown looking upstream. Spring 2011

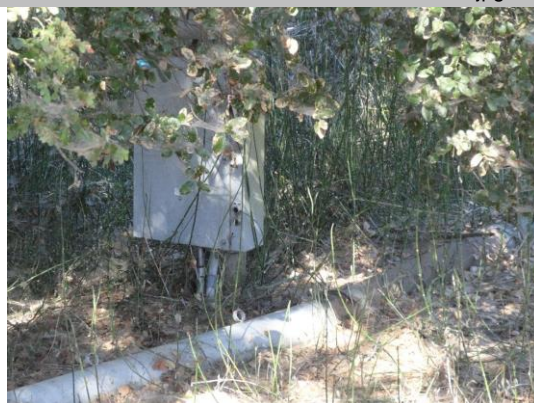
Photo 2 of 2 : UCIP_FA_2018_20284_34264.jpg

Comment Code						
Inspector Comment						
FS_ID:20284 DS_ID:22419 EP_NO: N/A Repair Type: Non-Urgent Crossing Status: Found UCIP Comments: Needs proper abandonment. FIELD_STRUCT_DESC: 8-inch steel irrigation discharge pipe through the levee, invert elevation 5.7 feet below the crown. Power line on the landside (LS). (Retention of an irrigation pumping plant, a centrifugal pump, and an 8-inch steel pipe through the levee with a gate valve at the waterside [WS] end authorized under Permit No. 9446, 1974 - Hanna Olsen). [Additional Reference(s): DWR Levee Log, 2005. USACE Sacramento O&M Manual 112, March 1957, (RM 34.49)]. FS Date: 8/27/2013

LS view: exposed steel pipe and power pole on levee toe.

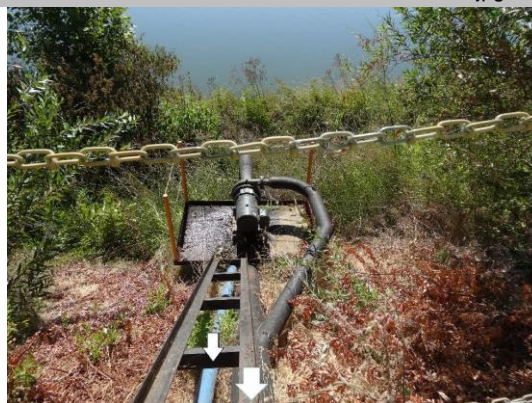
Photo 1 of 3 : UCIP_FA_2018_20303_34287.jpg

WS view: slant pump on steel deck, 4-inch pipe (left) and 10-inch pipe (right) on levee slope.

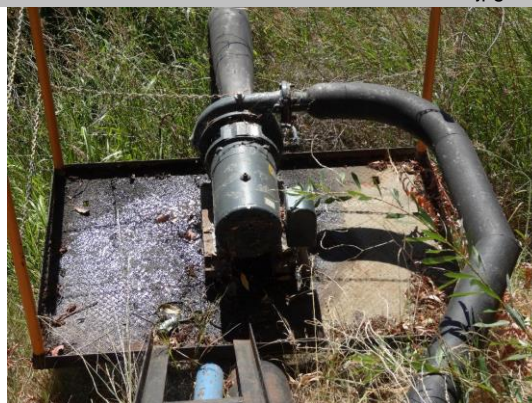
Photo 2 of 3 : UCIP_FA_2018_20303_34286.jpg

WS view: steel pipes and leaky slant pump on steel deck.

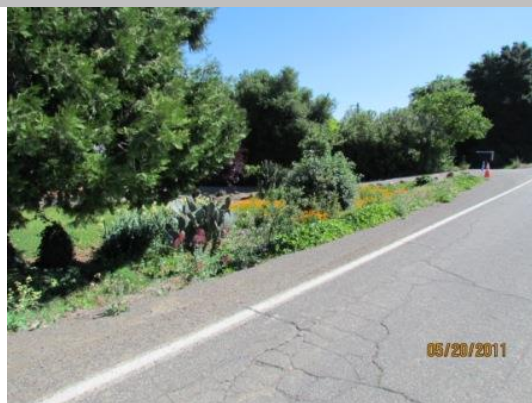
Photo 1 of 1 : FA_2018_RD0150_16_88_20180910_00056.jpg

Unpermitted landscaping was found on the landside slope of the levee.
The picture was taken from the crown looking upstream. Spring 2011

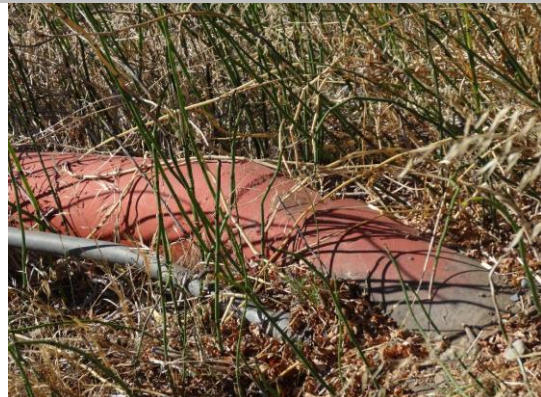
Photo 2 of 3 : UCIP_FA_2018_20736_34916.jpg

WS view: steel pipe and GI conduit on levee slope.

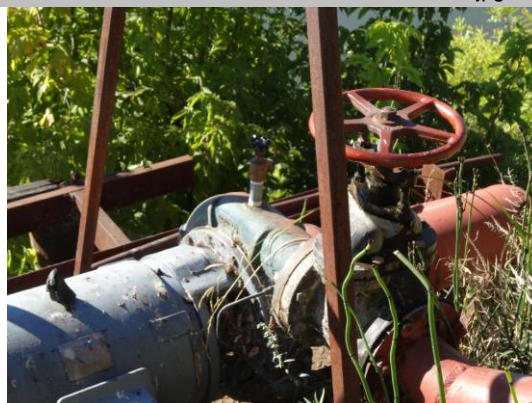
Photo 3 of 3 : UCIP_FA_2018_20736_34915.jpg

WS view: pipe and pump on levee slope. Gate valve and air vent on the pipe.

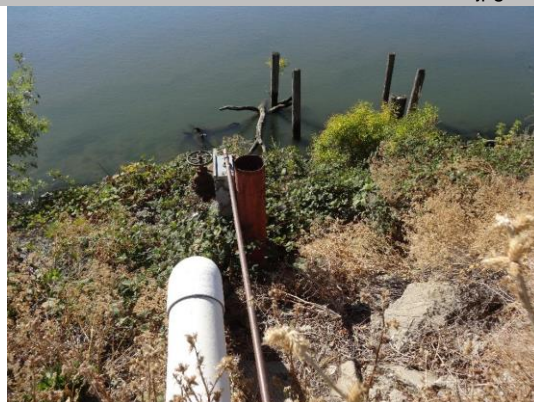
Photo 1 of 3 : UCIP_FA_2018_19846_33727.jpg

WS view: pipe, pump, and conduit on levee slope.

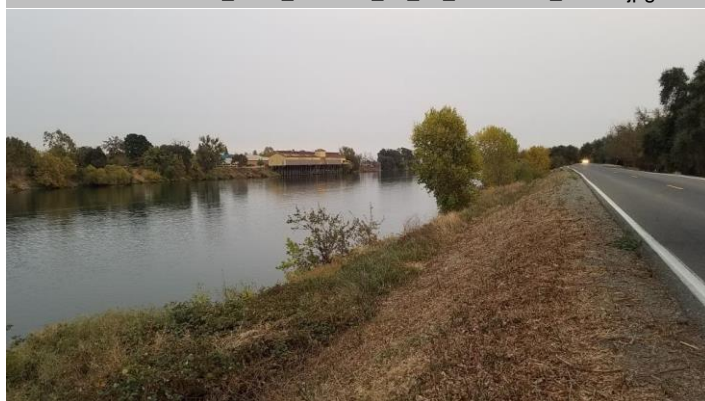
Photo 2 of 2 : FA_2018_RD0150_16_44_20181115_00140.jpg

View of waterside slope. Fall 2018

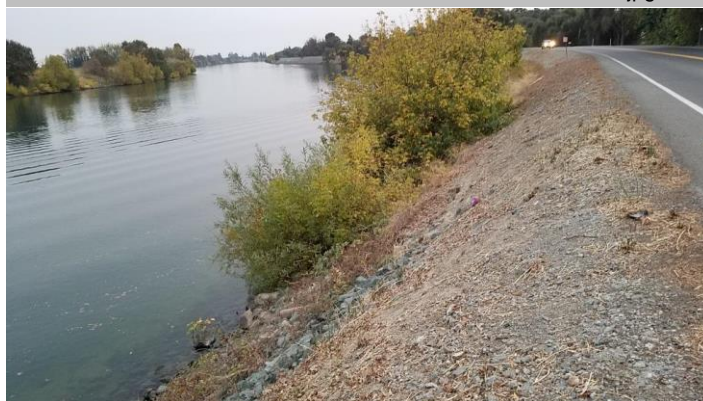
Photo 1 of 4 : FA_2018_RD0150_16_50_20181115_00141.jpg

View of waterside slope with some revetment. Fall 2018

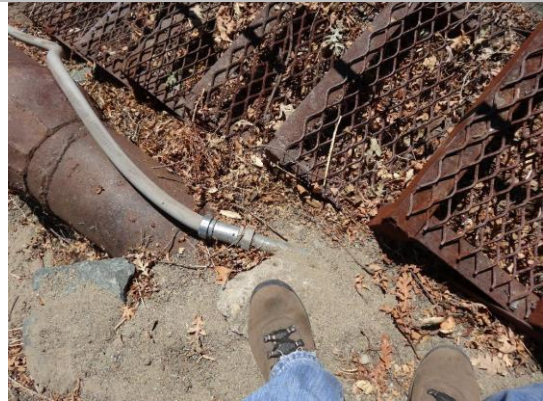
Photo 3 of 3 : UCIP_FA_2018_20740_34939.jpg

WS view: steel steps to pump platform, exposed steel pipe, and electric conduit on levee slope.

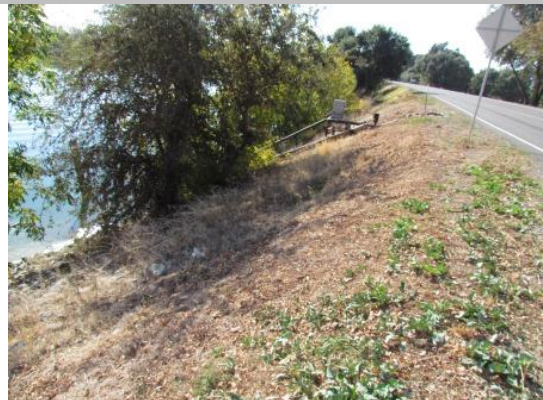
Photo 1 of 2 : FA_2018_RD0150_16_975_20180910_00070.jpg

View of minor slope instability on the waterside slope of the levee looking downstream during fall 2013 inspection.

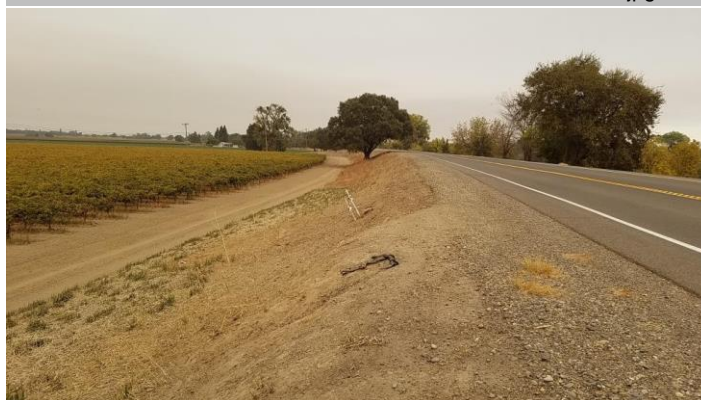
Photo 1 of 2 : FA_2018_RD0150_16_52_20181115_00131.jpg

View of erosion due to runoff. Fall 2018

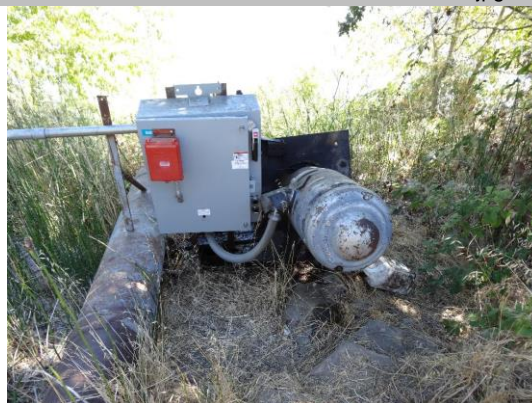
Photo 1 of 3 : UCIP_FA_2018_20748_34967.jpg

WS view: steel pipe and slant pump on levee slope.

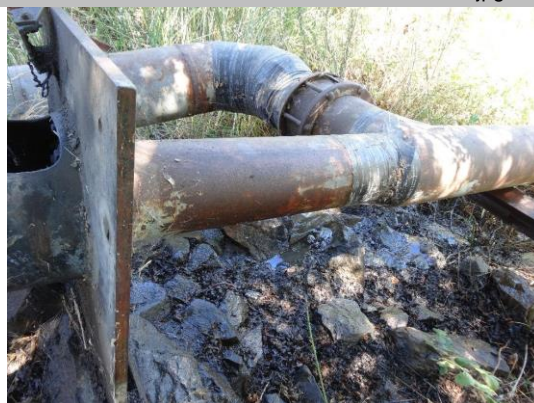
Photo 2 of 3 : UCIP_FA_2018_20748_34966.jpg

WS view: leaky steel pipe and slant pump on levee slope.

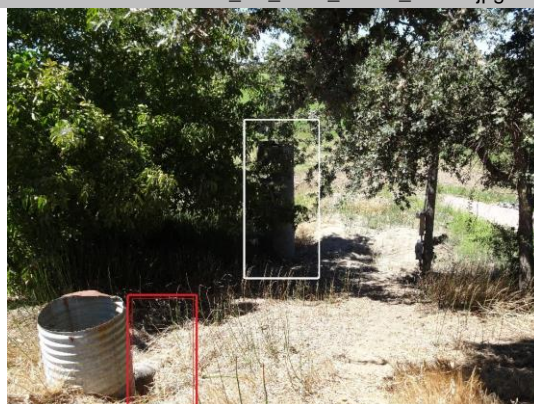
Photo 3 of 3 : UCIP_FA_2018_20748_34965.jpg

LS view: siphon breaker in CMP riser (left) on levee slope and concrete standpipe at levee toe (right).

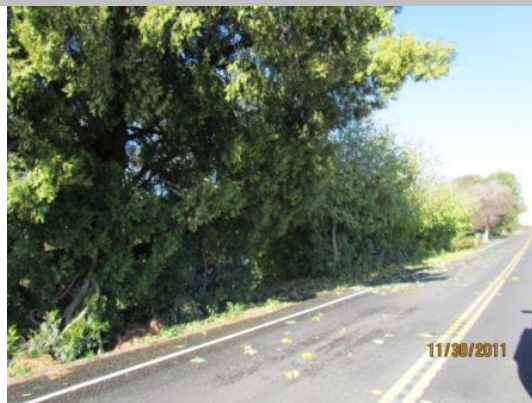
Photo 1 of 1 : FA_2018_RD0150_16_31_20180910_00015.jpg

Trees need to be trimmed on the landside of the levee looking upstream. Fall 2011

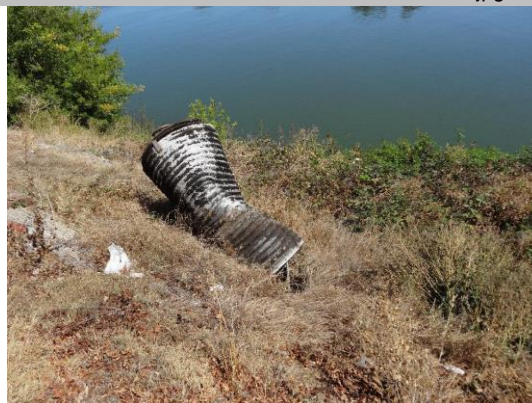
Photo 1 of 3 : UCIP_FA_2018_50669_34985.jpg

WS view: an abandoned and dismantled CMP riser on WS levee slope.

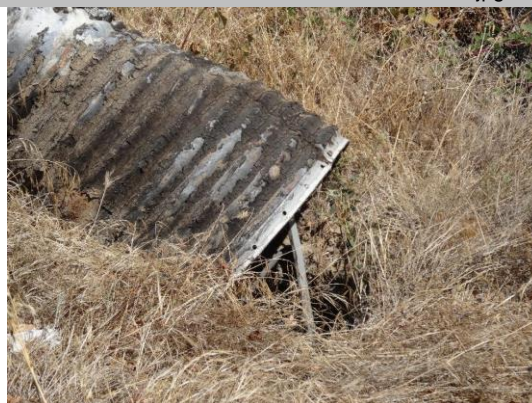
Photo 2 of 3 : UCIP_FA_2018_50669_34984.jpg

WS view: closer view of an abandoned and dismantled CMP riser on WS levee slope.

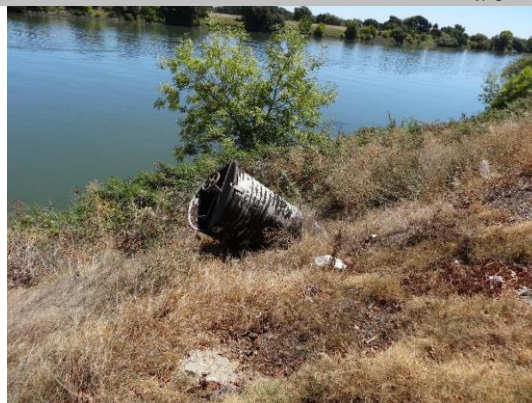
Photo 3 of 3 : UCIP_FA_2018_50669_34983.jpg

WS view: an abandoned and dismantled CMP riser with gate valve handle on WS levee slope.

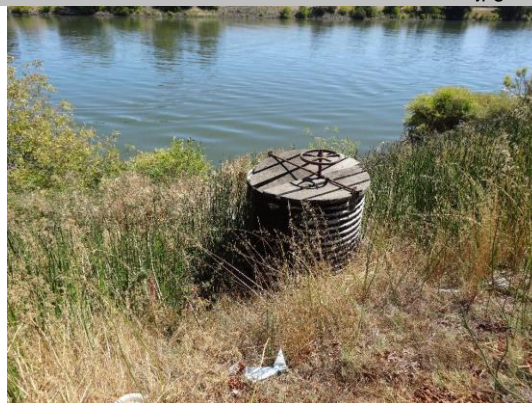
Photo 1 of 2 : UCIP_FA_2018_41720_34081.jpg

WS view: CMP riser with gate valve on levee slope. Dense vegetation on levee slope and stream bank.

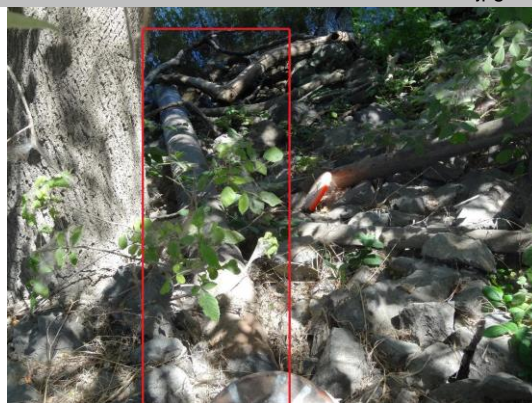
Photo 1 of 3 : UCIP_FA_2018_41646_34102.jpg

WS view: inlet steel pipe on stream bank.

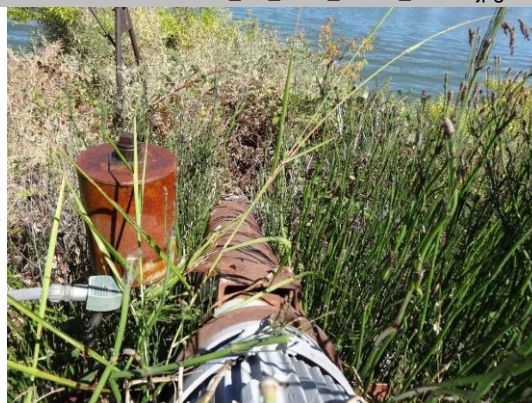
Photo 2 of 3 : UCIP_FA_2018_53333_34161.jpg

WS view: steel intake pipe and pump on levee slope. Dense vegetation on levee slope.

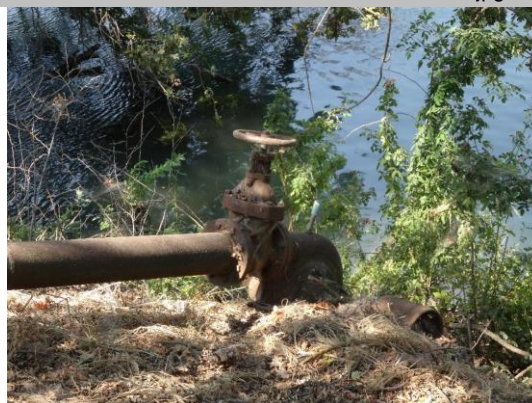
Photo 1 of 3 : UCIP_FA_2018_42694_32005.jpg

WS view: pipe and pump on levee slope.

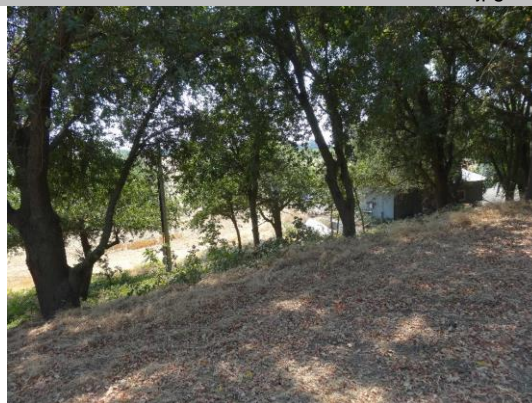
Photo 2 of 3 : UCIP_FA_2018_42693_31978.jpg

LS view: no pipe on levee slope.

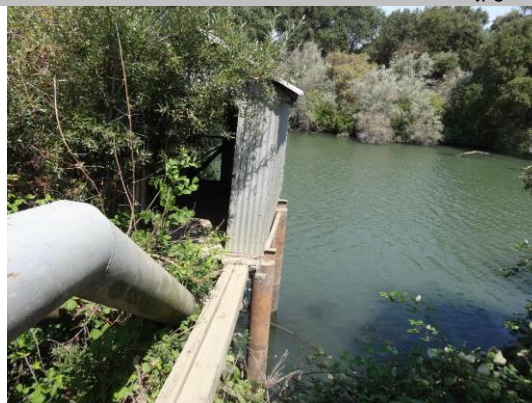
Photo 3 of 3 : UCIP_FA_2018_19112_32042.jpg

WS view: pipe, wooden walkway and pump house in channel.

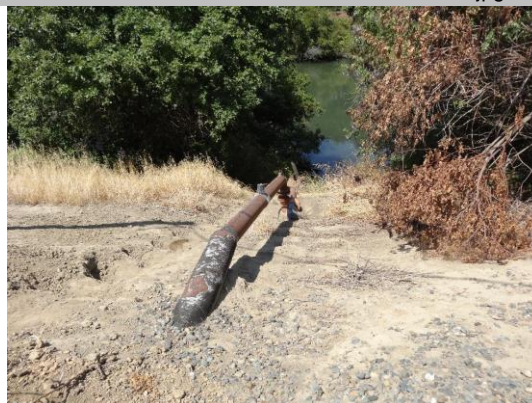
Photo 2 of 3 : UCIP_FA_2018_19137_32107.jpg

WS view: exposed pipe on levee slope.

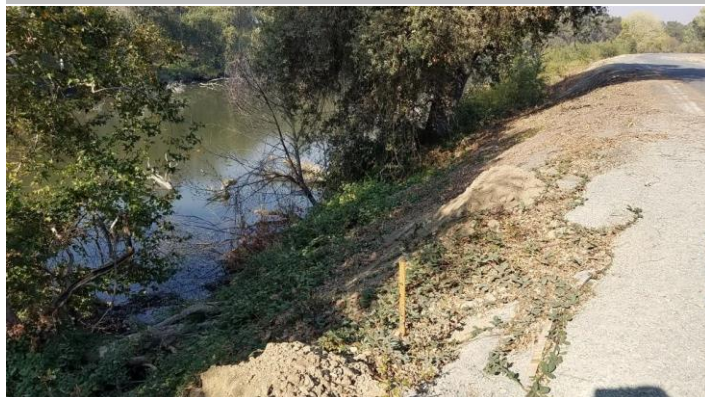
Photo 1 of 2 : FA_2018_RD0150_17_35_20181115_00190.jpg

View of erosion at top of slope. Fall 2018

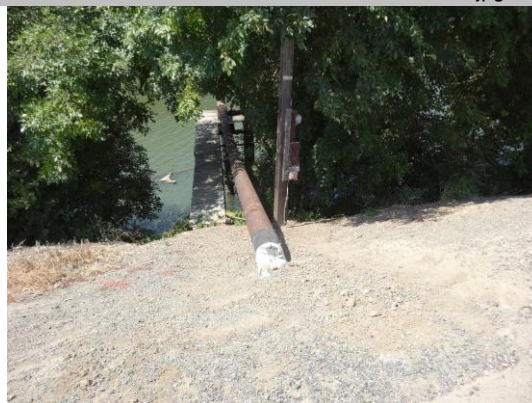
Photo 1 of 3 : UCIP_FA_2018_53334_35013.jpg

WS view: exposed pipe, walkway, service pole on levee slope and pump support in channel.

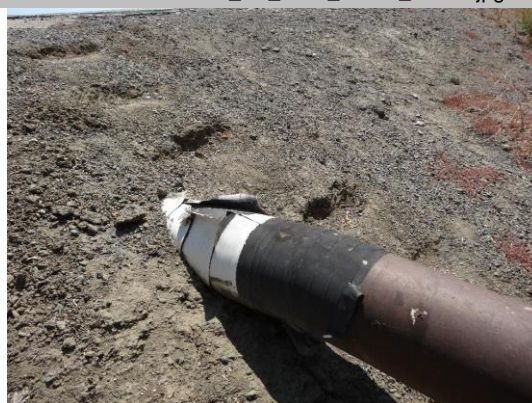
Photo 3 of 3 : UCIP_FA_2018_53334_35011.jpg

LS view: exposed pipe on levee slope.

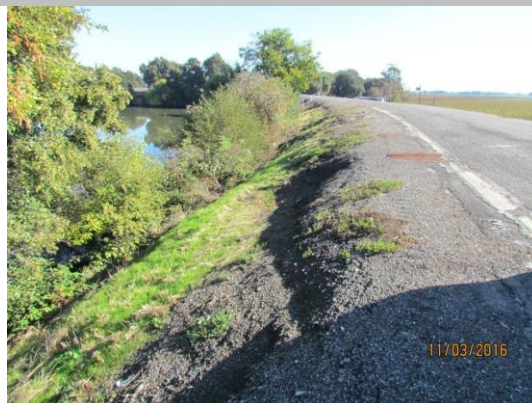
Photo 1 of 1 : FA_2018_RD0150_17_116_20180910_00114.jpg

View of slope instability on the waterside of the levee. Fall 2016

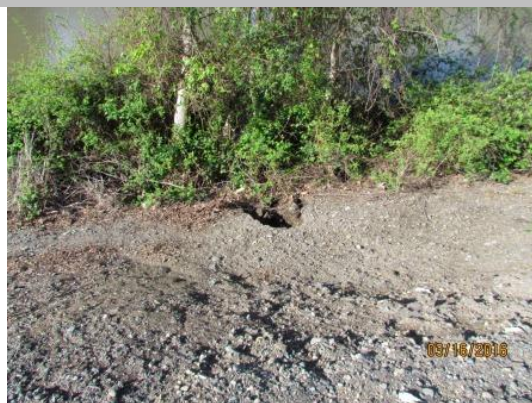
Photo 1 of 1 : FA_2018_RD0150_17_93_20180910_00090.jpg

Erosion was found on the waterside toe of the levee. Spring 2016

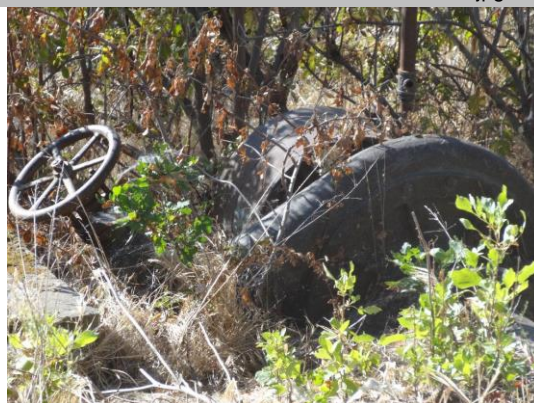
Photo 3 of 3 : UCIP_FA_2018_19283_32563.jpg

LS view: abandoned pump and gate valve on levee slope.

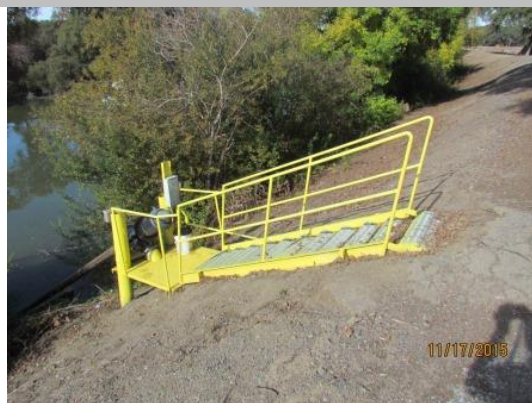
Photo 1 of 1 : FA_2018_RD0150_17_48_20180910_00037.jpg

View of a stairway on the waterside of the levee. Fall 2015

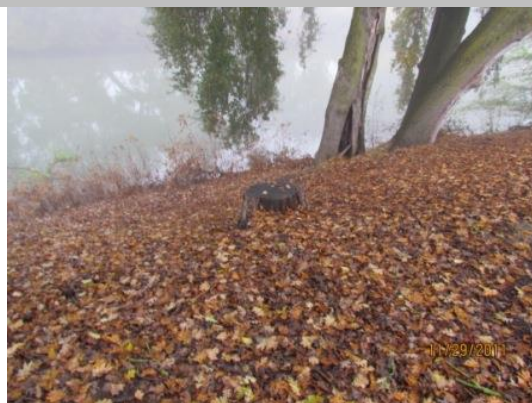
Photo 1 of 1 : FA_2018_RD0150_17_68_20180910_00060.jpg

Tree stump was found on the waterside of the levee looking upstream.
Fall 2011

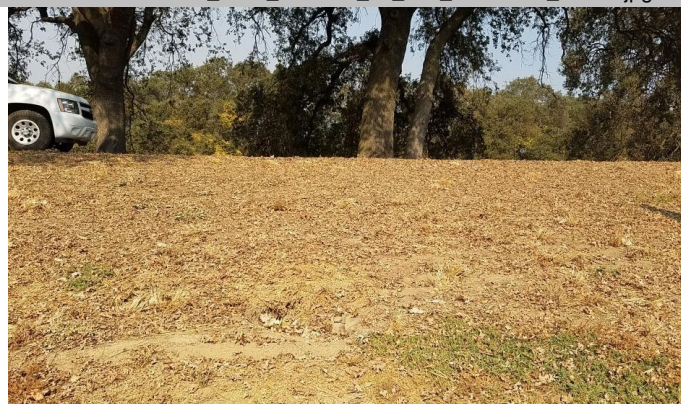
Photo 1 of 2 : FA_2018_RD0150_17_104_20181115_00196.jpg

View of animal hole on landside toe. Fall 2018

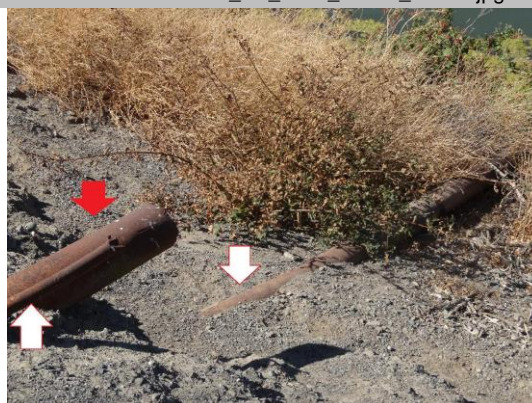
Photo 1 of 3 : UCIP_FA_2018_19403_32942.jpg

WS view: open ended 6" steel pipe (top-left), 1" steel pipe (bottom), and
another 6" steel pipe (right) on levee slope.

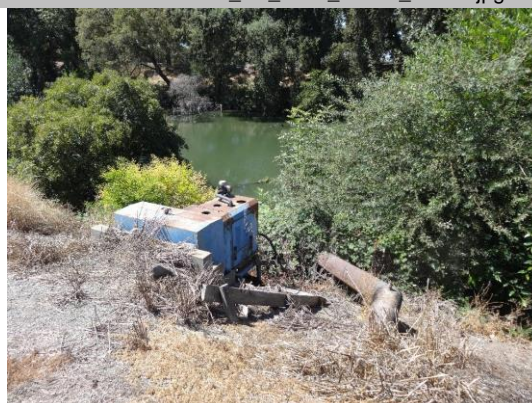
Photo 1 of 3 : UCIP_FA_2018_42692_35082.jpg

WS view: steel pipe (right) and diesel pump on levee slope.

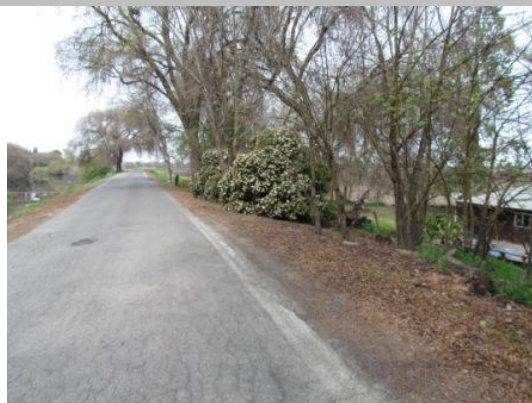
Photo 1 of 1 : FA_2018_RD0150_17_31_20180910_00012.jpg

Landscaping was found on the landside shoulder of the levee looking upstream.

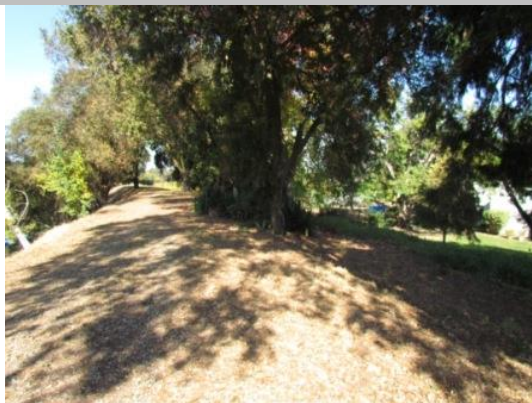
Photo 1 of 1 : FA_2018_RD0150_17_84_20180910_00079.jpg

Landscaping was found on the landside shoulder of the levee looking upstream.

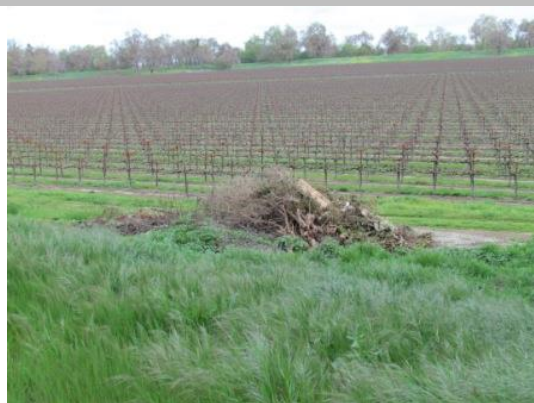
Photo 1 of 2 : FA_2018_RD0150_17_935_20180910_00137.jpg

Prunings were found on the landside of the levee looking upstream.

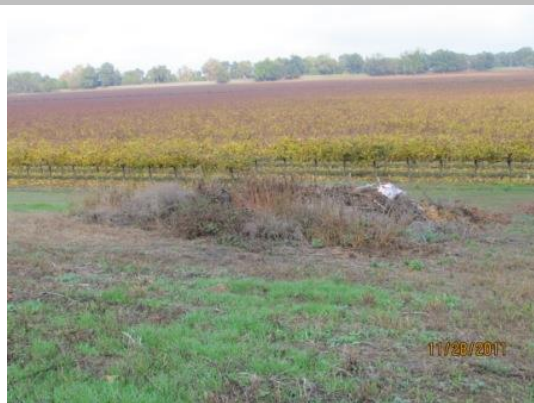
Photo 2 of 2 : FA_2018_RD0150_17_935_20180910_00138.jpg

Prunings were found on the landside of the levee looking upstream. This picture was taken during fall 2011 inspection.

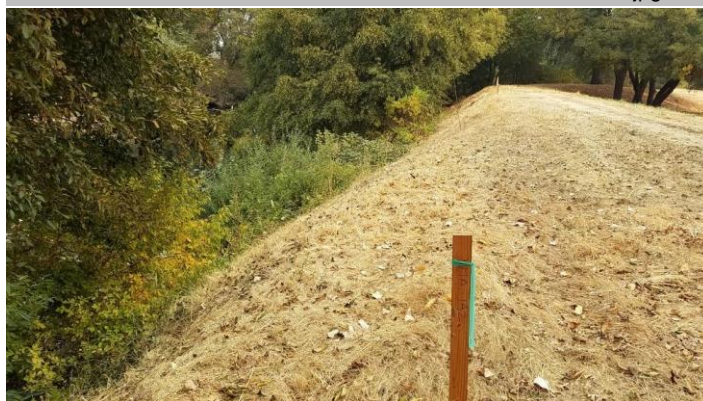
Photo 1 of 4 : FA_2018_RD0150_17_122_20181115_00204.jpg

View of waterside slope. Fall 2018

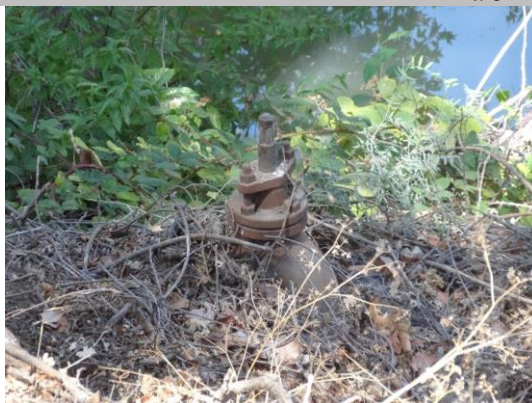
Photo 2 of 3 : UCIP_FA_2018_53335_33626.jpg

WS view: abandoned gate valve found on levee slope.

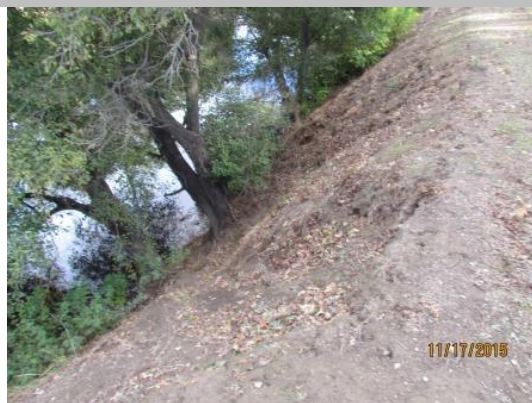
Photo 1 of 1 : FA_2018_RD0150_17_65_20180910_00056.jpg

View of erosion on the waterside of the levee. Fall 2015

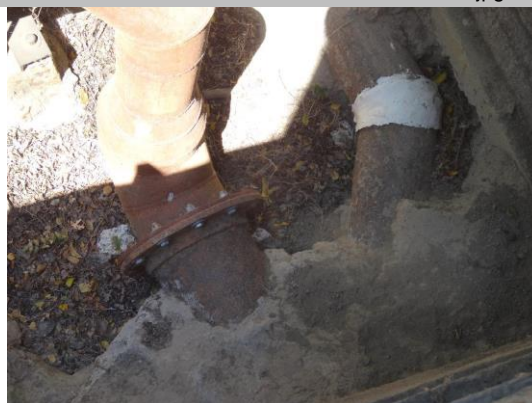
WS view: 8-inch steel pipe (right) next to 12" pipe (left). This 8" pipe might have merged with 12" pipe under the levee .

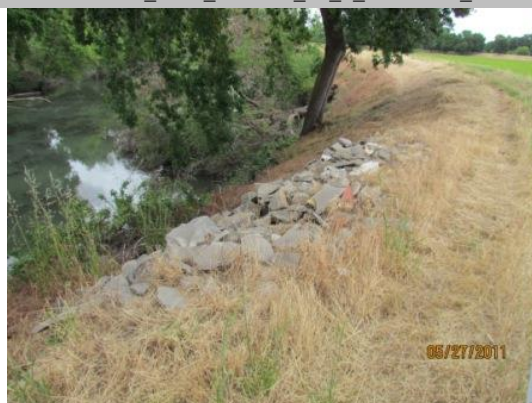
Broken concrete pipe was left on the waterside slope of the levee. The picture was taken from the crown looking upstream. Spring 2011
